**Flood Control Project Maintenance
Levee Inspections**

Fall 2012 Levee Maintenance Deficiency Summary Report

Sacramento River Basin

Reclamation District No. 0817 Carlin

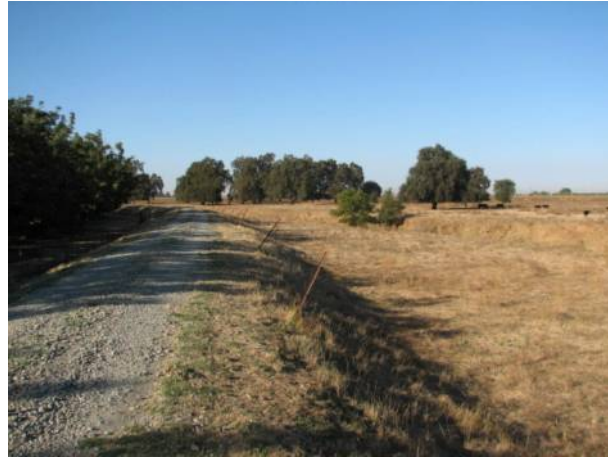
Levee Mile Report Line	4
Start Levee Mile	0.01
End Levee Mile	0.60
Location	Water Side
Category	Earthen Levee
Item	Vegetation

Levee mile 3.80, the waterside slope.

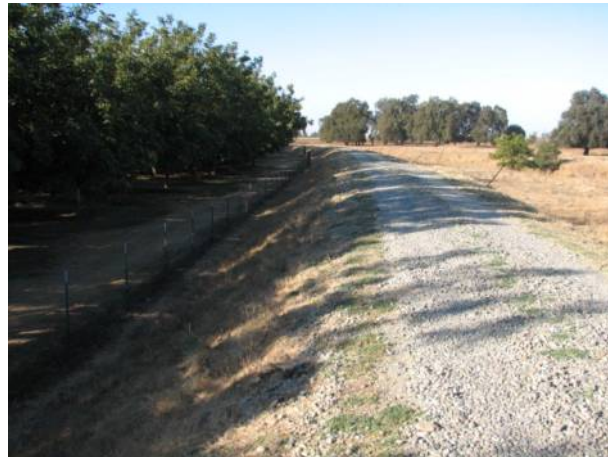
Levee Mile Report Line	5
Start Levee Mile	0.01
End Levee Mile	0.60
Location	Land Side
Category	Earthen Levee
Item	Vegetation

Levee mile 3.80, the landside slope.

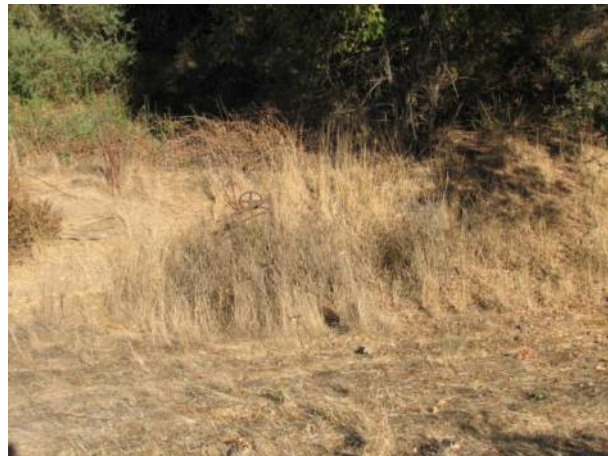
Levee Mile Report Line	6
Start Levee Mile	1.34
End Levee Mile	1.34
Location	Land Side
Category	Earthen Levee
Item	Encroachments

This screw gate is not operating properly.

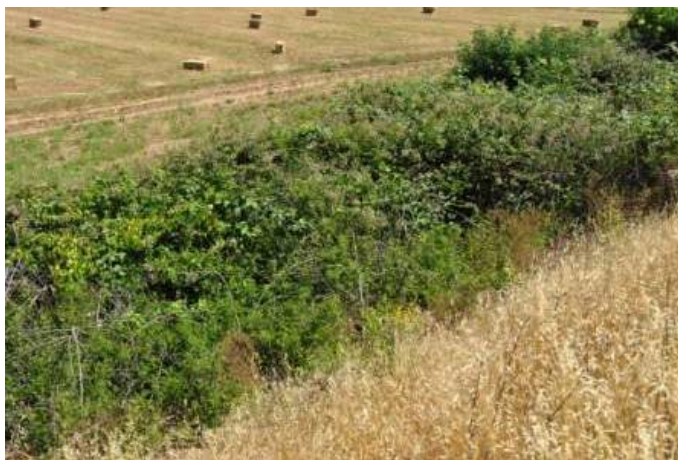
Levee Mile Report Line	3
Start Levee Mile	0.27
End Levee Mile	0.27
Location	Land Side
Category	Earthen Levee
Item	Vegetation

RD 817 Unit 2 - L/S Vegetation - Blackberries & Wild Rose

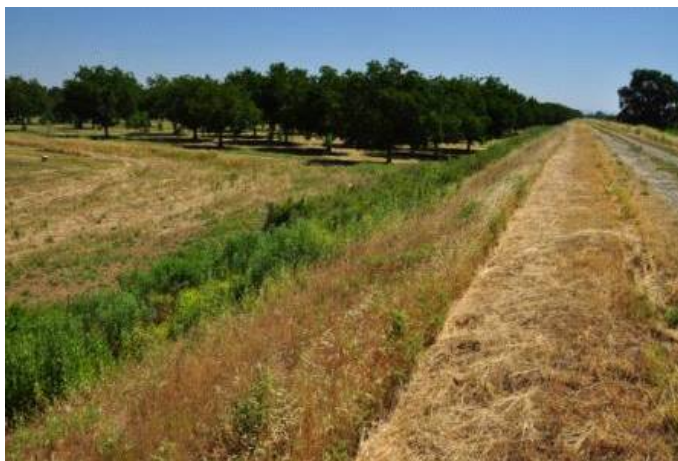
Levee Mile Report Line	4
Start Levee Mile	0.32
End Levee Mile	0.32
Location	Land Side
Category	Earthen Levee
Item	Vegetation

RD 817 Unit 2 - L/S Vegetation - Wild Rose

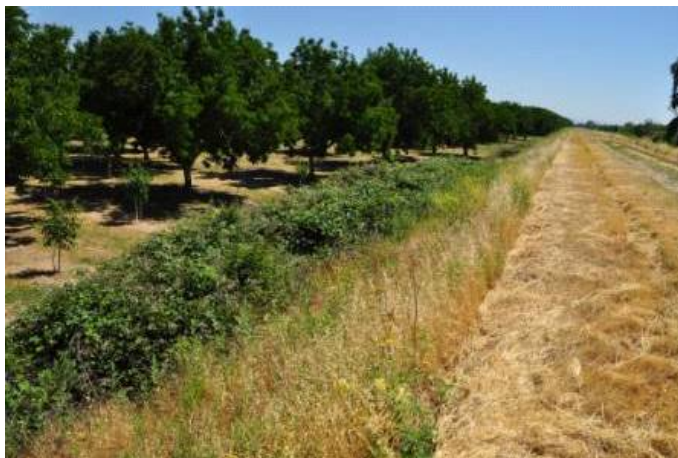
Levee Mile Report Line	5
Start Levee Mile	0.39
End Levee Mile	0.39
Location	Land Side
Category	Earthen Levee
Item	Vegetation

DWR ID: DWR_RD0817_02_s_2012_2										
5	0.39	0.39	Earthen Levee	Vegetation	LS	U Ma	V2 : Remove the wild growth other than native grasses from the levee slopes. Inspector Comments: Dense berry bushes along lower slope.	38.984542 ° -121.499283 °	38.984542 ° -121.499283 °	3 Y
DWR ID: DWR_RD0817_02_s_2012_3										
6	1.00	3.80	Earthen Levee	Vegetation	LS	A Ma	V1 : Control annual grass and weeds on the levee slopes and easements.	38.983962 ° -121.504625 °	38.992974 ° -121.438201 °	8 Y
DWR ID: DWR_RD0817_02_f_2012_8										
7	1.76	1.82	Earthen Levee	Vegetation	LS	M En	V6 : Landscaping	38.987792 ° -121.474295 °	38.988118 ° -121.473372 °	6 Y
DWR ID: DWR_RD0817_02_s_2012_6										
8	2.08	3.19	Earthen Levee	Slope Stability	LS	M Ma	S1 : Repair slope instability.	38.989338 ° -121.468640 °	38.994124 ° -121.449448 °	10 Y
DWR ID: DWR_RD0817_02_s_2012_10

RD 817 Unit 2 - L/S Vegetation - Blackberries & Wild Rose

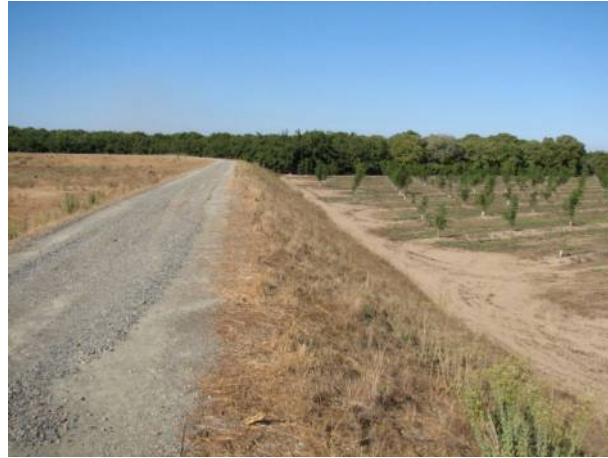
Levee Mile Report Line	6
Start Levee Mile	1.00
End Levee Mile	3.80
Location	Land Side
Category	Earthen Levee
Item	Vegetation
Levee mile 3.22, the landside slope.	
cathom_f_20121128_286.JPG

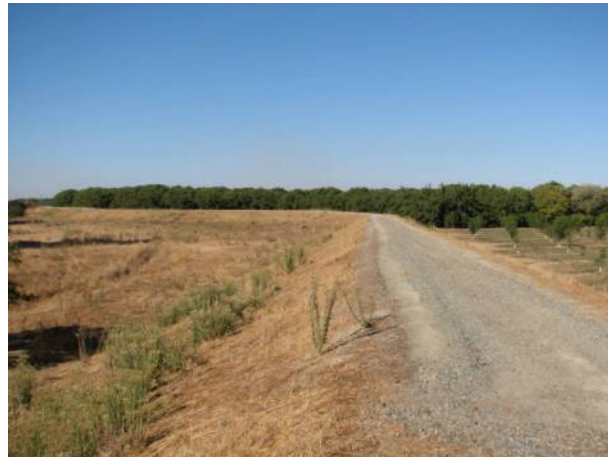
Levee Mile Report Line	6
Start Levee Mile	1.00
End Levee Mile	3.80
Location	Land Side
Category	Earthen Levee
Item	Vegetation
Levee mile 3.22, the waterside slope.	
cathom_f_20121128_287.JPG

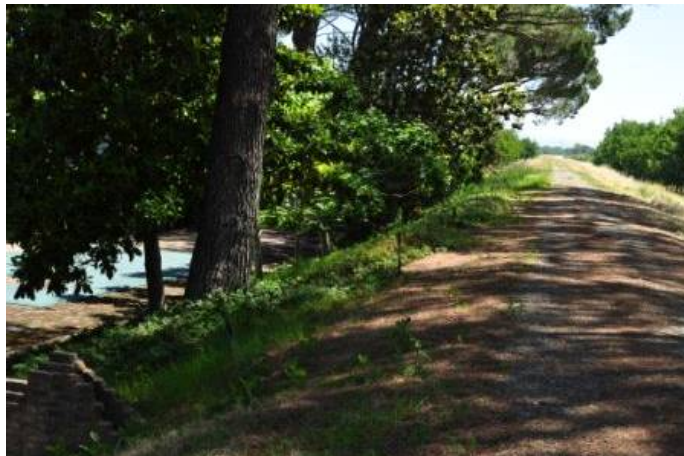
Levee Mile Report Line	7
Start Levee Mile	1.76
End Levee Mile	1.82
Location	Land Side
Category	Earthen Levee
Item	Vegetation
RD 817 Unit 2 - L/S Landscaping	
cathom_f_20120912_066.JPG

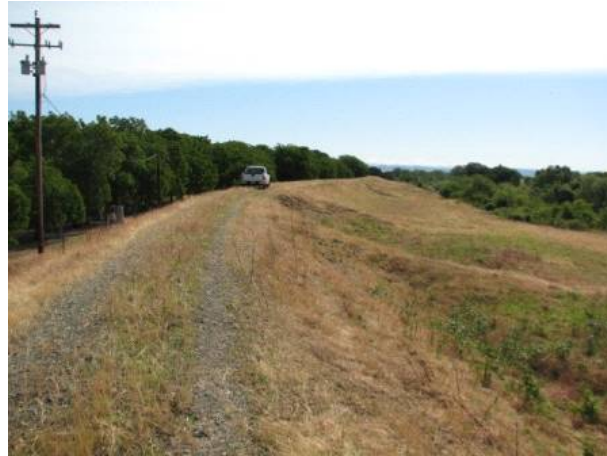
Levee Mile Report Line	8
Start Levee Mile	2.08
End Levee Mile	3.19
Location	Land Side
Category	Earthen Levee
Item	Slope Stability

Levee mile 2.08, this photo shows the slope is less than required, this is the downstream limit of the site, this is the waterside slope.
